**ASTM C 423 SOUND ABSORPTION
TEST REPORT**

FABRI TRAK SYSTEMS, INC.

SERIES/MODEL: 1/2" FABRI TACK™

Report No: B6698.01-113-11
Revision 1: 07/09/15
Test Date: 01/31/12
Report Date: 02/17/12
Record Retention End Date: 02/17/16

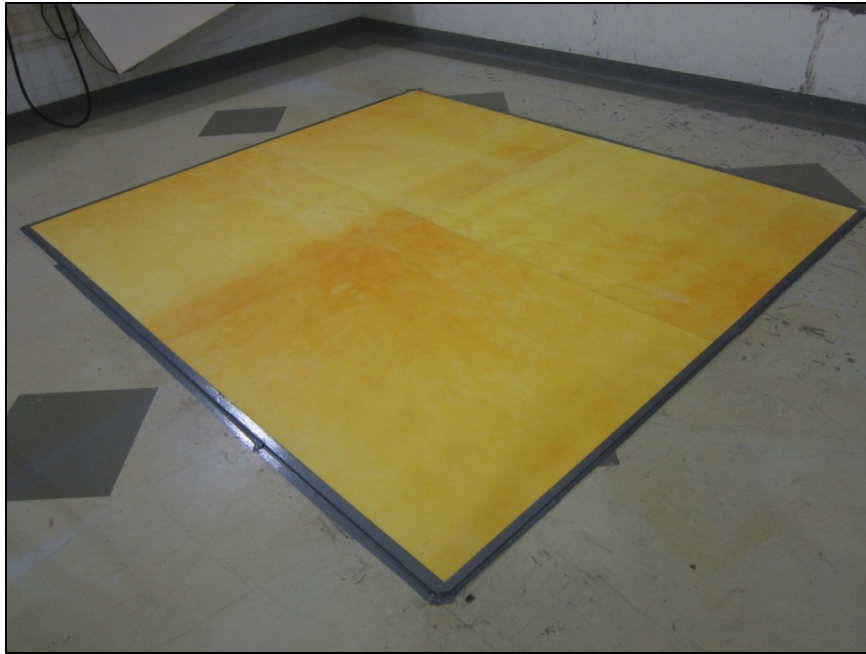
Receive Room View of Installed Specimen

The test sample consisted of four, 1.22 m by 1.37 m (48" by 54") panels, which were arranged to produce a 2.43 m by 2.74 m (8.00' by 9.00') sample. The total weight of the sample was 15.02 kg (33.12 lbs). The sample test setup was photographed with a digital camera, and the pictures are included in Appendix C.
